## Case Study: Vegetation Encroachment Risk Assessment

DISTRIBUTION NETWORK VEGETATION ENCROACHMENT AND RISK ASSESSMENT

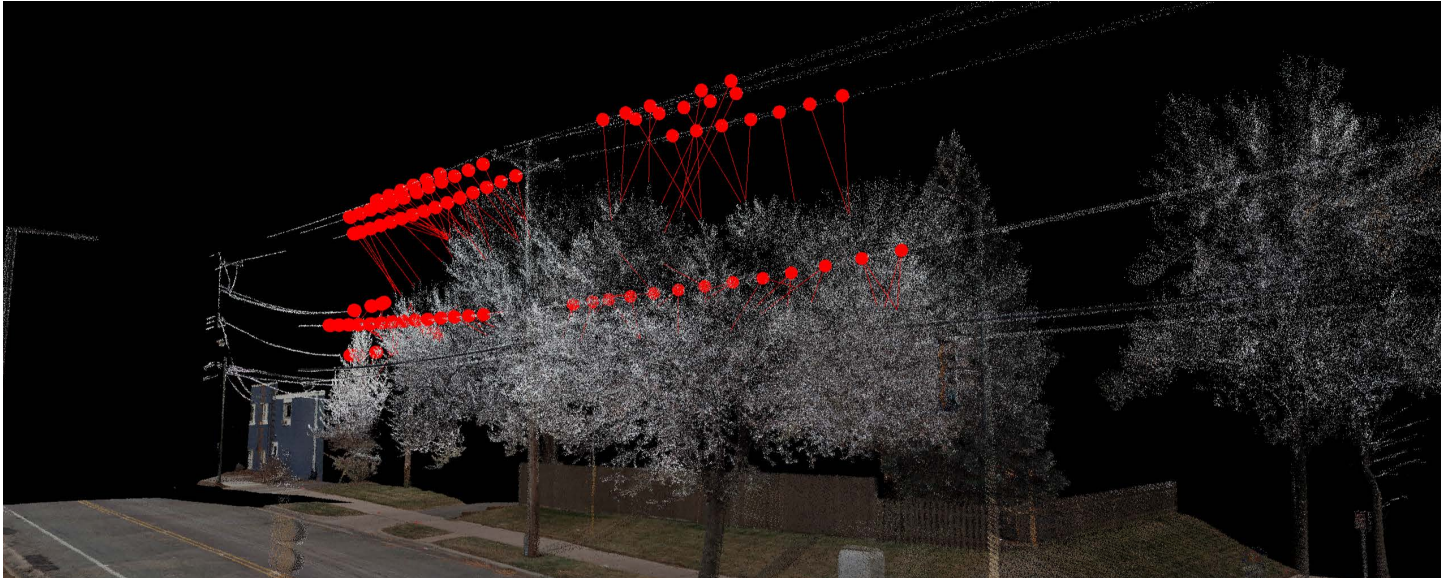
- Capture 360° imagery and LiDAR along overhead distribution lines based on threat level
- Perform data analytics to extract poles and conductors with critical attributes
- Run automated process to determine vegetation encroachment to conductors and ground FLR

- 20,000+ miles of accurate, detailed encroachment & FLR results that were previously unavailable
- Fine-grained data points (every 3 ft) aggregated as risk vectors along spans with severity
- Identified over 180,000 high fire threat (4 ft or closer) encroachments
